### Anatomical shape, support and colour provided by the use of a patient-specific abutment – Atlantis™ abutment, GoldHue

36 years-old patient with a vertical fracture of 46. The treatment plan was to extract the tooth and replace it by a dental implant. In this conventional placement with conventional loading treatment, the challenge was to restore the position of the gingival contour and the inter-proximal papillae like in the natural tooth, giving in the area of the transitional contour the anatomical shape, support and colour provided by the use of a patient-specific abutment.

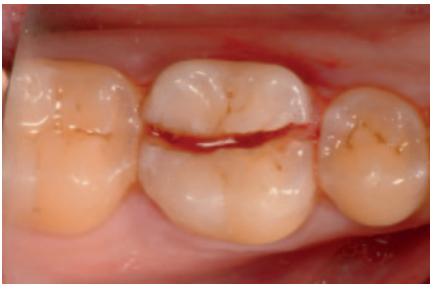
**1.** A vertical fracture of 46. When probing there was a distal narrow isolated pocket measuring more than 15 mm.

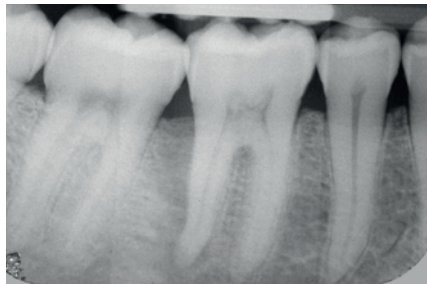
**2.** In the x-ray we could observe a radio-lucency along the distal wall of the distal root with the typical "J" shape seen in vertical root fractures.

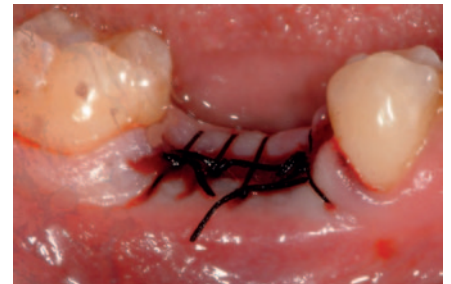
**3.** The tooth extraction was done without damaging the alveolar walls. The socket was scraped and sutured without using grafting material.

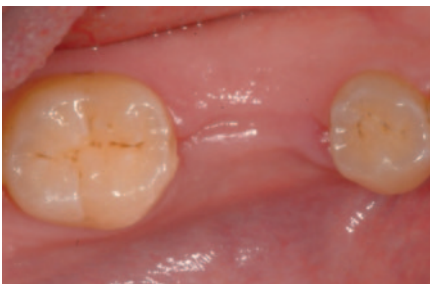
**4.** After 8 weeks of healing period, the soft tissue covers totally the area of extraction.

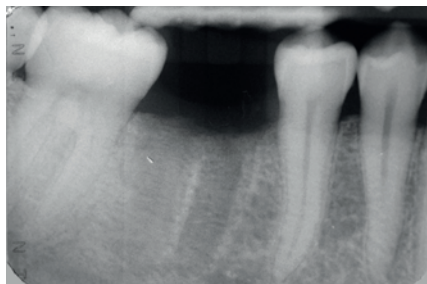
**5.** After 8 weeks, the amount of bone formation into the socket permitted the implant placement.

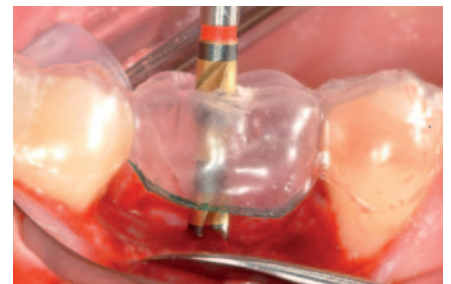
**6.** Using the surgical stent, the osteotomy for placing the implant was done in an adequate position in the 3 dimensions, using as a reference point the zenith of the cervical contour of the planned restoration.

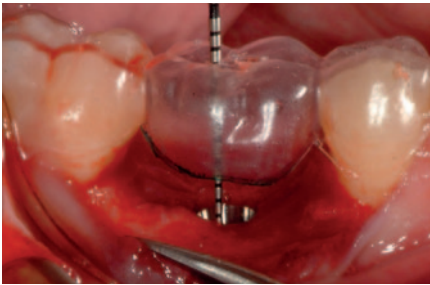
**7.** Using the surgical stent the implant was placed 3 mm apical to the cervical contour of the restoration and symmetrically from mesial to distal and 2 mm lingually for preserving the buccal bone that will support the soft tissue.

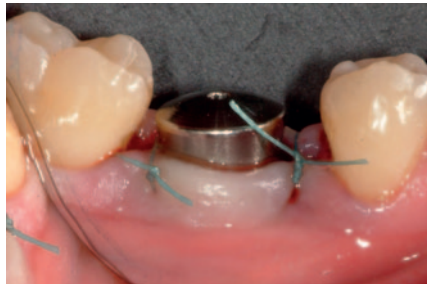
**8.** A 7 mm healing abutment was placed to guide the soft tissue to this circular diameter during the healing process.

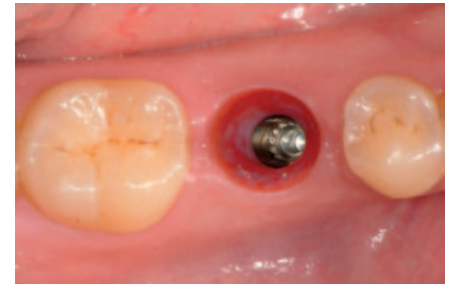
**9.** The healing abutment was removed after 6 weeks and a definitive impression of the implant position was sent together with the opposite model to the laboratory.

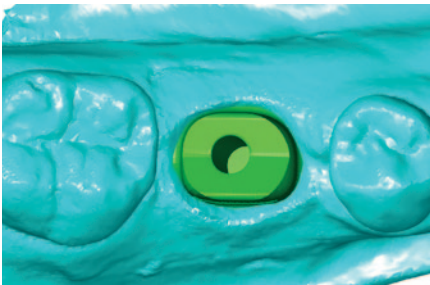
**10.** The Atlantis™ abutment was virtually designed with the emergence profile of the molar that must be replaced and then it was processed in the material of choice.

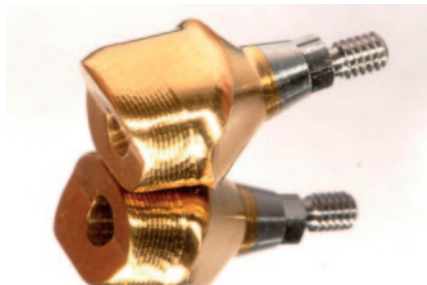
**11.** The Atlantis™ abutment, GoldHue, together with the Atlantis™ abutment screw, was sent to the dental technician.

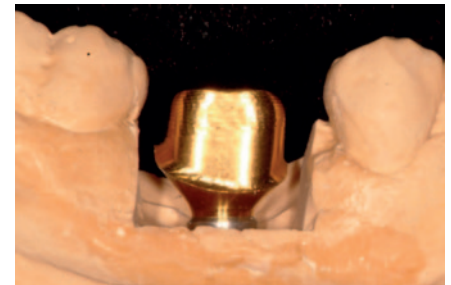
**12.** The Atlantis™ abutment is verified in the working model and the definitive restoration in zirconia porcelain is fabricated.

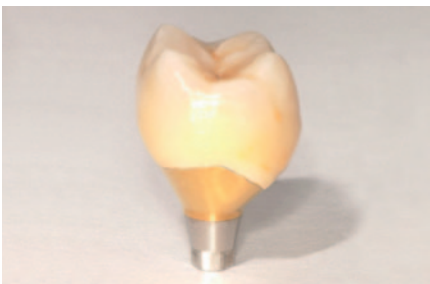
**13.** Final implant restoration ready to be delivered to the clinician.

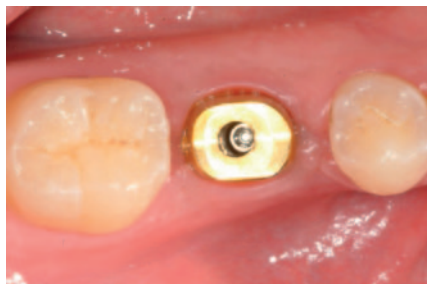
**14.** The Atlantis™ abutment was placed with some pressure into the soft tissue; after some minutes the ischemia disappeared and the abutment went down to its right position.

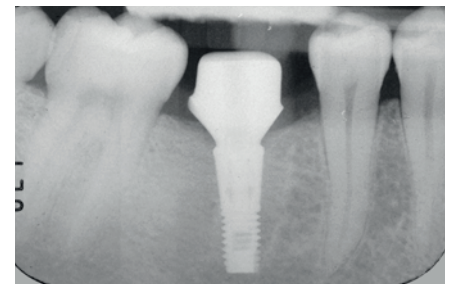
**15.** Verify correct seating of the abutment using a radiographic image, the transitional portion of the abutment follow the contour of the bone.

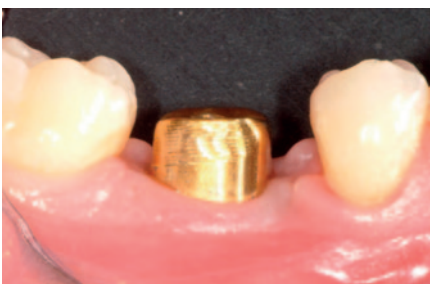
**16.** The Atlantis™ abutment, GoldHue was torqued according to the implant manufacturer's torque recommendation – 25 Ncm. The screw head was covered and later on the crown was cemented to the abutment.

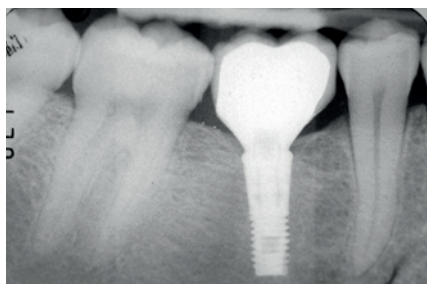
**17.** X-ray showing the perfect fit of the restoration, the spaces created for the interproximal papillae and the position of the bone at the level of the implant.

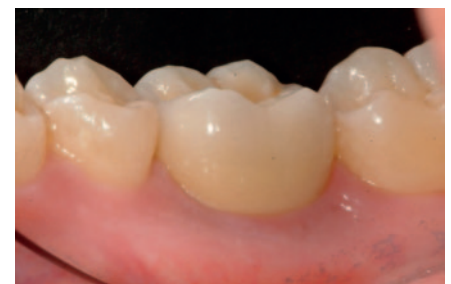
**18.** After 9 months we observed a perfect adjustment of soft tissue around the restoration, filling the space for the interproximal papillae and giving a natural position of the soft tissue contour.
