## Mandibular fixed restoration using the Astra Tech Implant System® EV and SmartFix® concept

A 62-year-old male patient with a terminal dentition underwent implant treatment and was restored with a screw retained monolithic zirconia restoration. After full mouth extractions, immediate complete dentures were placed that restored the esthetics and function for the patient. Following 12 weeks of healing, placement of four mandibular implants was planned with Simplant. Aided by the CAD/CAM Simplant guide, four OsseoSpeed EV implants were placed with flapless surgery, tilting the two posterior implants. Multibase Abutments EV 30° were connected to the posterior implants. Immediate loading was applied using the existing prosthesis. A definitive monolithic zirconia<sup>1</sup> prosthesis was made for the Atlantis suprastructure.

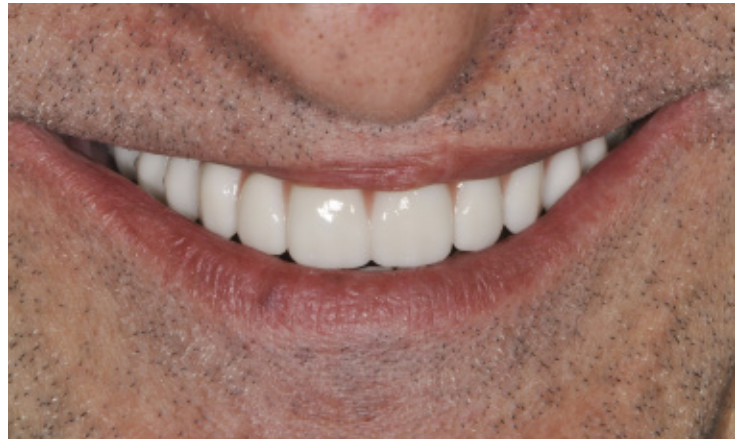
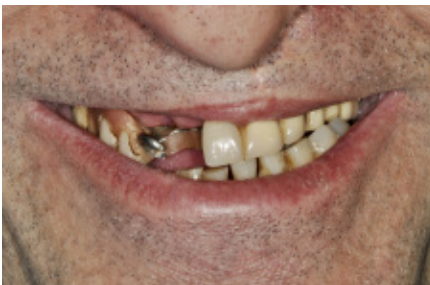
**1.** The patient's initial situation, with removable partial dentures, presented a correct vertical dimension, but an exaggerated inclination of the occlusal plane, creating a non-esthetic smile.

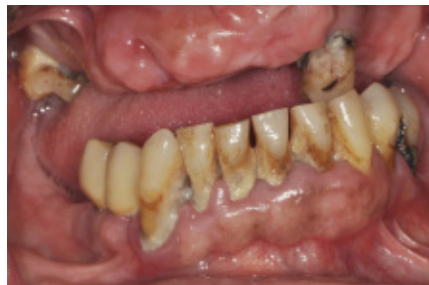
**2.** In the intraoral examination the reduced interocclusal space and the inclination of the maxillary and mandibular ridges were seen.

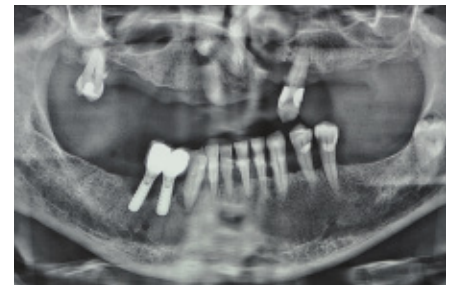
**3.** Panoramic radiographs visualized the inclination of the entire interocclusal space. Two previously placed implants presented signs of peri-implantitis. All remaining teeth showed signs of periodontal disease with a bone loss of more than 50%.

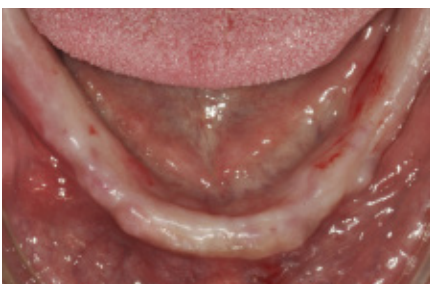
**4.** Twelve weeks after tooth extraction and explantation of two implants, correct healing was observed with adequate keratinized gingiva.

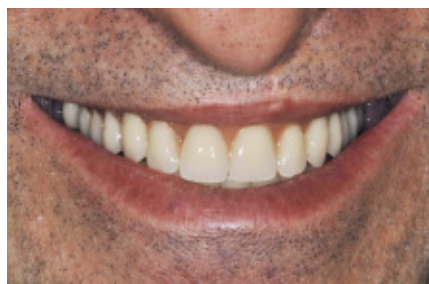
**5.** With new provisional complete dentures, the occlusal plane was corrected achieving an adequate smile for the patient, where the maxillary incisal curve was parallel to the lower lip during the smile. The best labial support was also achieved with the anteroposterior position of the maxillary and mandibular teeth.

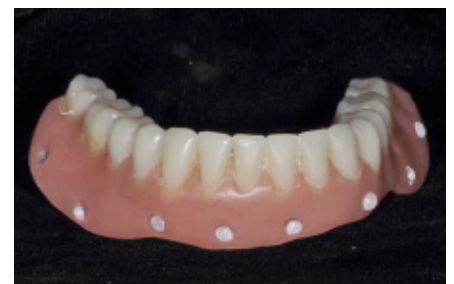
**6.** For the double scanning technique, dual scan markers were glued on the prosthesis using light curing resin. The patient was scanned wearing the interim complete dentures, then the prosthesis was scanned alone.

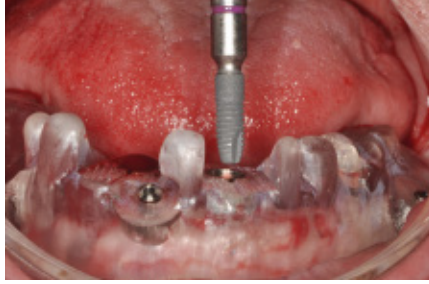
**8.** The tissue supported Simplant guide was fixed with three micro-screws. Four OsseoSpeed EV implants were placed following the drilling protocol. All implants were torqued to 35 Ncm.

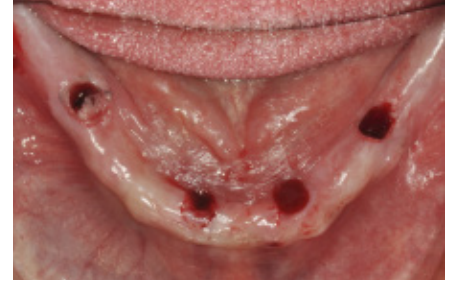
**9.** After the implants were placed and the Simplant guide removed, very little bleeding was observed around the circular incisions.

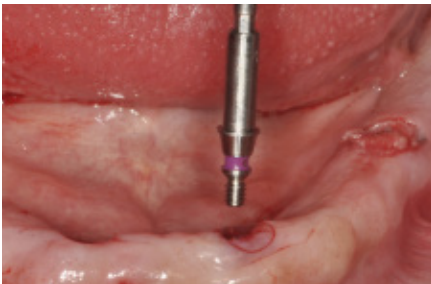
**10.** Because the implants were placed slightly subcrestal, it was necessary to use the Bone Reamer to ensure correct adjustment of the abutments. For this the corresponding Bone Reamer guide was screwed into the implant.

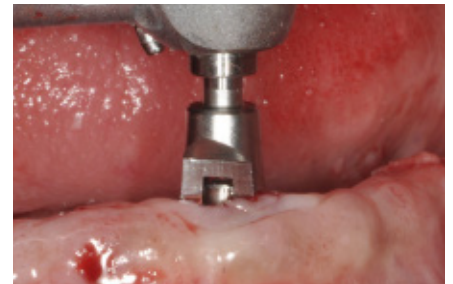
**12.** The correct depth of the Bone Reamer was verified ensuring that the Bone Reamer Guide was in contact with the inside of the Bone Reamer.

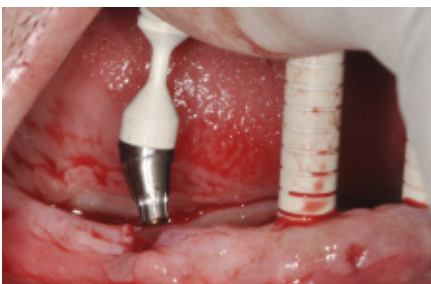
**13.** Multibase Abutments EV were used for the anterior implants and indexed Multibase Abutments EV 30° were selected for the posterior implants. The abutment body was rotated until achieving parallelism with the abutment holder of the anterior implants.

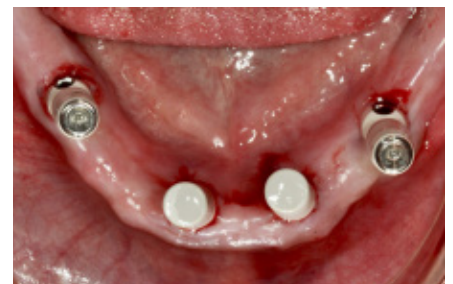
**15.** Once the two posterior Multibase Abutments EV bodies were placed, the abutment holders were maintained to ensure parallelism between all four abutments.

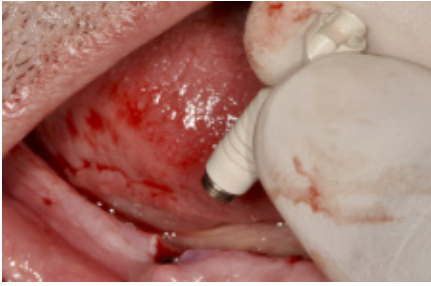
**19.** Attached on the other end of the abutment holder is the abutment head with a cone taper 21°, which is screwed on the abutment body. The handle is then easily snapped off.

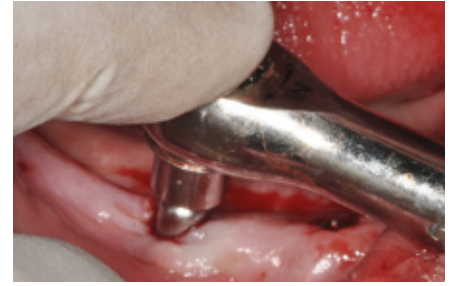
**21.** Using the restorative driver handle together with the Multibase Driver EV and the torque wrench to tighten the abutment head to the recommended torque of 25 Ncm.

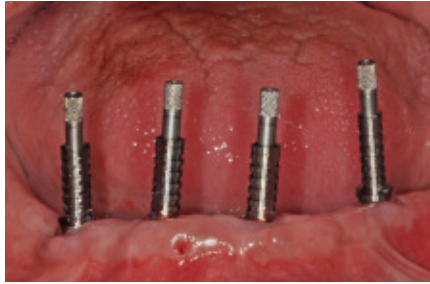
**23.** Multibase EV Temporary Cylinders were screwed into each abutment manually with a hexagonal screwdriver to verify parallelism. Lab abutment pins were used to avoid excess of fixation material inside of cylinders.

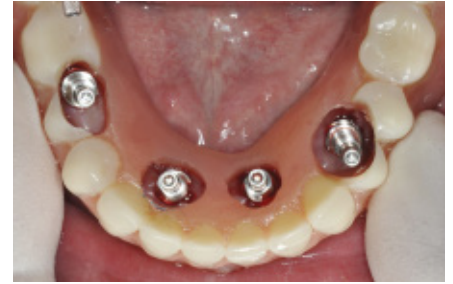
**24.** The existing prosthesis was perforated until there was no contact between the cylinders and the acrylic, obtaining the same adjustment on the soft tissue and the same occlusion.

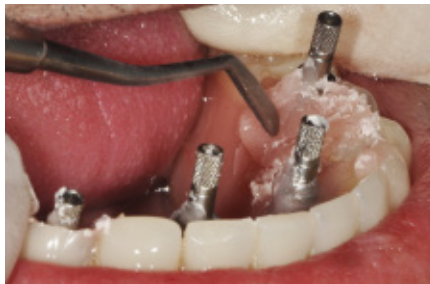
**26.** Holding the prosthesis in position given by the intact posterior support, acrylic resin was applied around the cylinders. The position of the prosthesis was maintained until the acrylic resin had set.

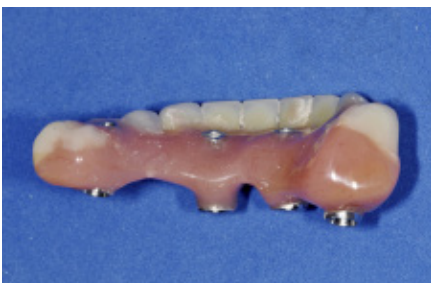
**28.** The vestibular and distal flanks were cut, without disturbing the prosthesis tissue junction, creating a convex shape that would facilitate the patient's dental hygiene maintenance. The prosthesis was polished, shone and left in chlorhexidine for 15 minutes.

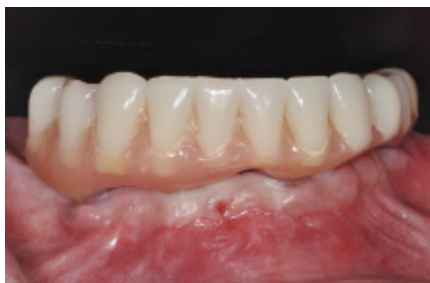
**29.** The prosthesis was attached to evaluate the occlusion, which was revised until bilateral contacts were established and no interference in excursion movements were found. Prosthesis was removed, polished, and then re-attached using a torque wrench to achieve a torque of 15 Ncm. The screw access holes were filled with Teflon and then covered with silicone.

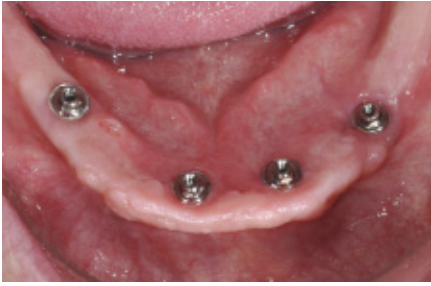
**31.** After six weeks of osseointegration, the prosthesis was removed and an adequate healing of the soft tissue around the abutments was observed.

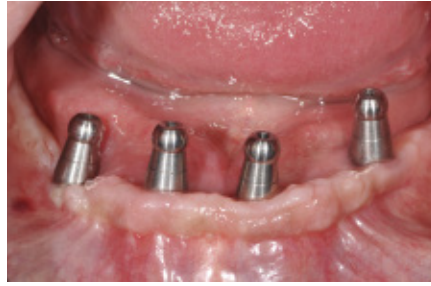
**32.** The final impression was taken using Multibase EV Transfers for closed tray.

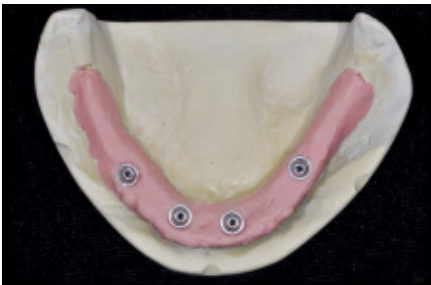
**34.** The silicone used to manufacture the soft tissue of the definitive cast was passed through a laboratory drill to regularize it and remove small irregularities of the soft tissue.

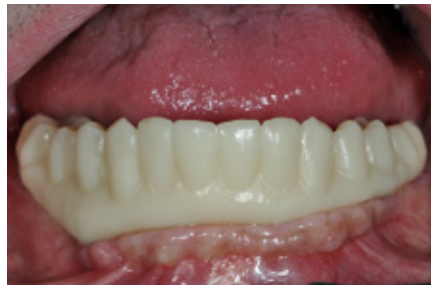
**35.** Definitive cast was scanned individually, then with the existing prosthesis and finally in occlusion with the antagonist. Then the prototype of the new prosthesis was designed and milled.

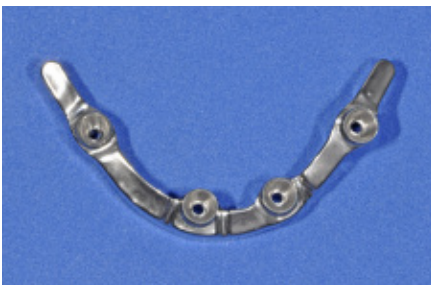
**37.** The bar was CAD/CAM manufactured in titanium and between each cylinder small concavities were made to facilitate the passage of dental floss.

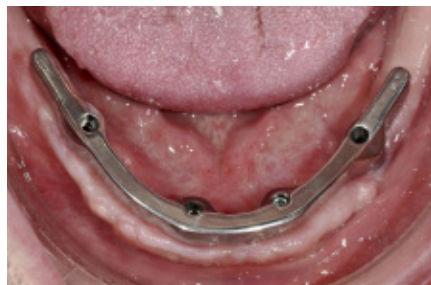
**38.** The passive fit of the bar was evaluated by attaching it in one end and then verifying that it fitted passively in the other three abutments.

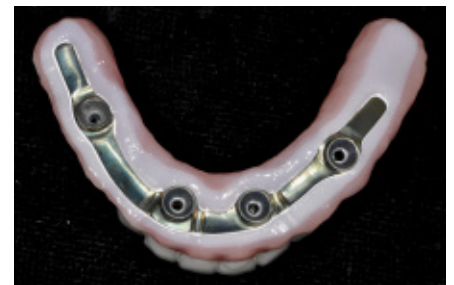
**39.** A new prosthesis was virtually designed keeping the space for the bar. Then the prosthesis was milled in monolithic zirconia and pink feldspathic ceramic was added in the area corresponding to the soft tissue. The bar was glued inside the prosthesis with a dual resin cement.

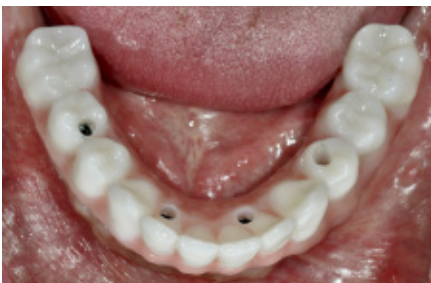
**40.** The prototype was replaced by the definitive screw-retained stained zirconia gingiva-colored ceramic implant-supported fixed prosthesis. It was screwed to 15 Ncm with the torque wrench, then the screw access holes were partially filled with Teflon and then with light-curing resin.

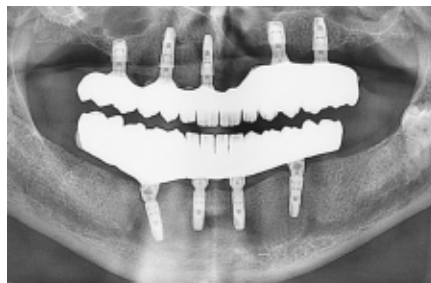
**41.** The panoramic radiograph shows the correct fit of the prosthesis on the abutments and the bone level above the shoulder of the implants.

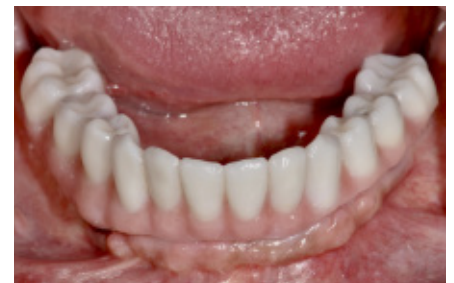
**42.** The fixed monolithic zirconia prosthesis was part of the total rehabilitation of the esthetics and function of the patient.
